NURSE'S PULPAL EXPOSURE

ADDITIONAL PULP CAPPING CASES

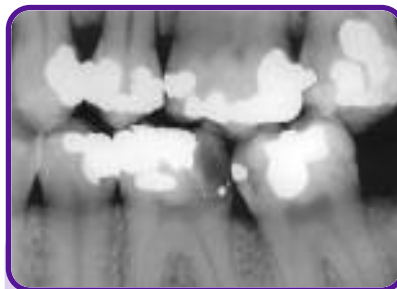
Figure KK1
Note large carious lesion on the distal of tooth #19.

Kathy's roommate was my patient and suggested that she come see me. Upon taking a radiograph, I saw a large carious lesion, which I thought could be treated (*Figure KK1*), so I suggested we try to save the tooth.

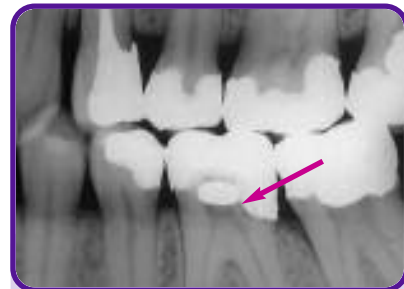
Figure KK2
Eighteen-year follow-up shows dense line of reparative dentin.

Kathy was thrilled that we were able to save the tooth, and she continued to have the rest of her dental work done. *Figure KK2* is a bitewing radiograph taken eighteen years later showing her completed dental treatment. Note the dense line of reparative dentin on the distal of the pulp chamber of tooth #19.

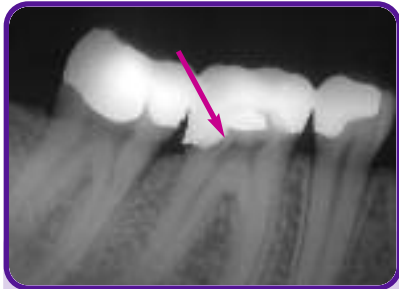
Figure APC1
Shows healing of a large exposure on the distal of a mandibular right first permanent molar (#30) following direct pulp capping with Pulpdent Paste. Note the new dentin bridge.

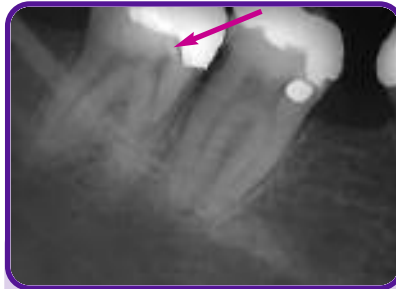
Figure APC2
Shows dentin bridge formation following pulp capping with Pulpdent Paste on the mesial of the mandibular right third molar (#32).

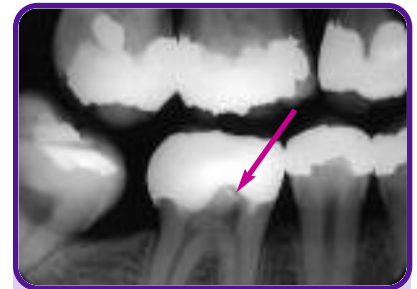
Figure APC3
Shows a new dentin bridge following pulp capping with Pulpdent Paste on the mesial pulpal horn of the mandibular right first permanent molar (#30).

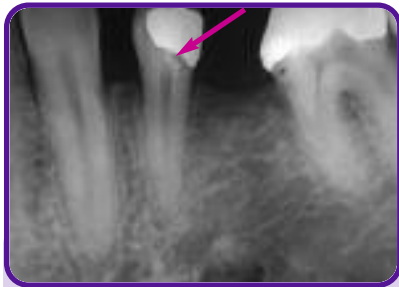
Figure APC4
Shows a healed pulp capping following treatment with Pulpdent Paste on the mandibular left first bicuspid (#21).

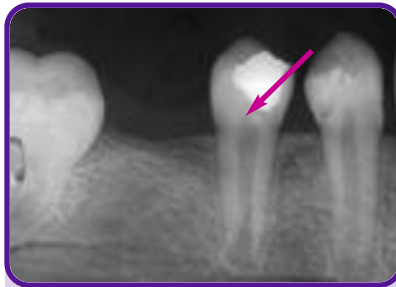
Figure APC5
Shows dentin bridge formation on the mandibular right second bicuspid (#29) of a twelve-year-old child one month following pulp capping with Pulpdent Paste. Note the incompletely formed roots.

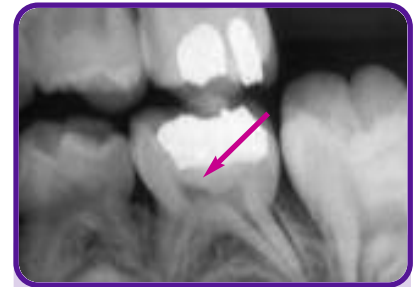
Figure APC6
Shows a new dentin bridge on a mandibular left second primary molar (#K) following treatment with Pulpdent Paste.

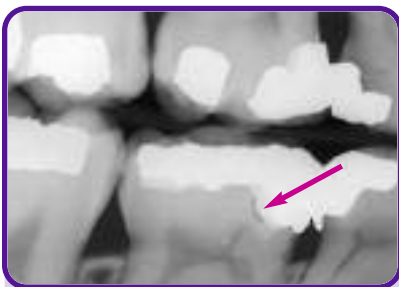
Figure APC7
Shows healing of the mandibular right second primary molar (#T) after pulp capping with Pulpdent Paste.

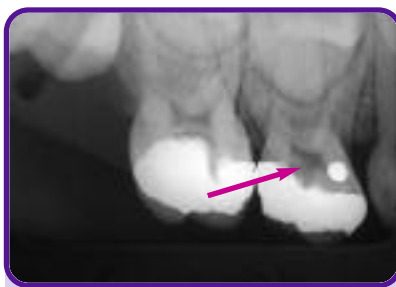
Figure APC8
Shows new dentin bridge formation of the maxillary right first primary molar (#A) following pulp capping with Pulpdent Paste.

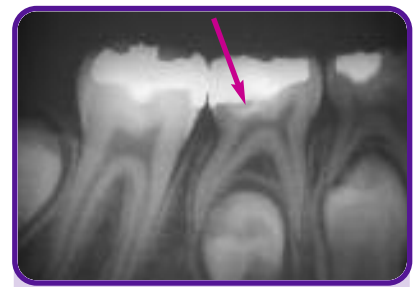
Figure APC9
Shows healing of a primary molar following pulp capping with Pulpdent Paste. Note the new dentin bridge and sclerotic dentin.
